MODELING AND INSTRUMENTATION DATA ANALYSIS FROM EXCAVATION SLOPE OF THE MISICUNI DAM SPILLWAY (BOLIVIA): A CASE STUDY

ABSTRACT - Slope stability analysis is of fundamental importance in infrastructure projects no matter its size. The failure of a slope has a major economic and environmental impact and can turn the project unfeasible, causing irreparable damage to the environment and life. Therefore, slope stability analysis aims to evaluate the possibility of a slope suffering mass movements and to propose stabilization solutions. This research focused on obtaining the resistance parameters of the materials found in the excavation slope of the Misicuni Dam spillway applying the back analysis method and using deformational instrumentation data. The parameter modeling can support future projects in terms of mechanical behavior and safety for the Misicuni Dam in addition to subsequent engineering projects in sedimentary rock masses deformed by tectonic influence. The Misicuni Dam is part of the Misicuni Multiple Project located in the Cochabamba department, central part of Bolivia. This project consists of using water from the Misicuni, Viscachas and Putucuni river basins. To carry o

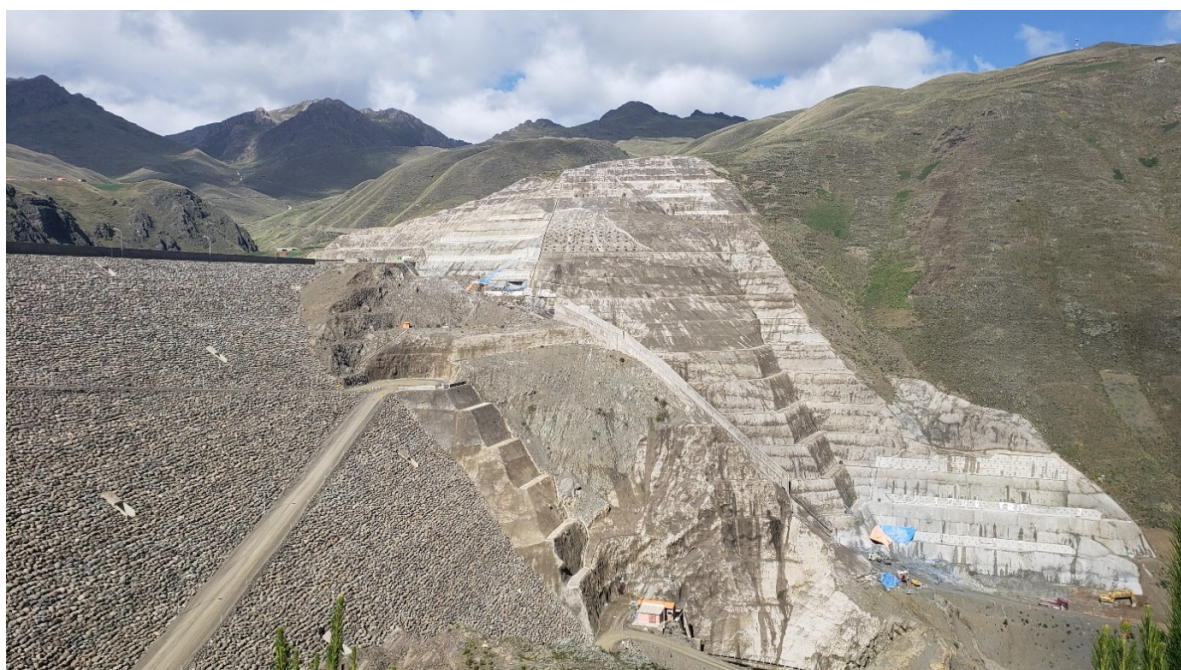
Figure 2 - General view of the Misicuni Dam and the spillway excavation slope. The red circle shows the location of the excavation slope.

The Misicuni Dam is a concrete-faced rockfill dam with a height of 120 m and a crest length of 490 m at an elevation of 3782 m above sea level (Figure 2). The upstream slope has a gradient of 1.5H:1.0V and the downstream slope 1.5H:1.0V with a 6.0 m wide berm that develops from the 3675 m elevation.

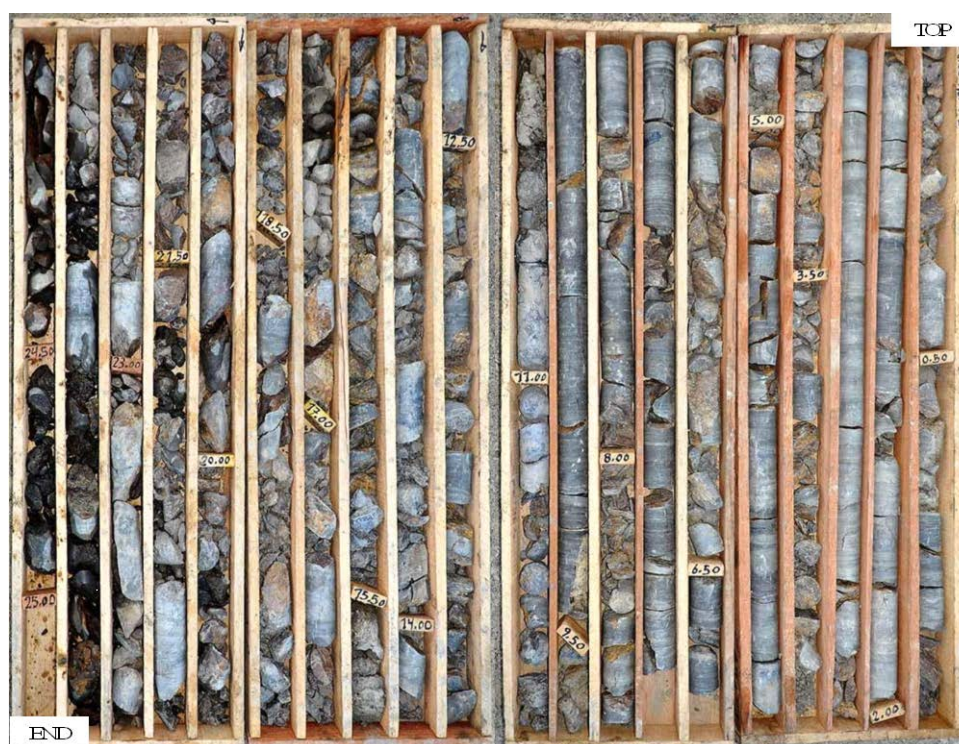
Figure 4 - Drill core SR-401 showing the rock mass quality.

spillway with a height of more than 30 m (Figure 3). To establish the geological cross-section for the excavation project, three boreholes were drilled along the highest section. Figure 4 shows the result of the SR-401 drill core, exemplifying the quality of the rock mass finding.
